A Motor Most Foul

by Stu Simpson

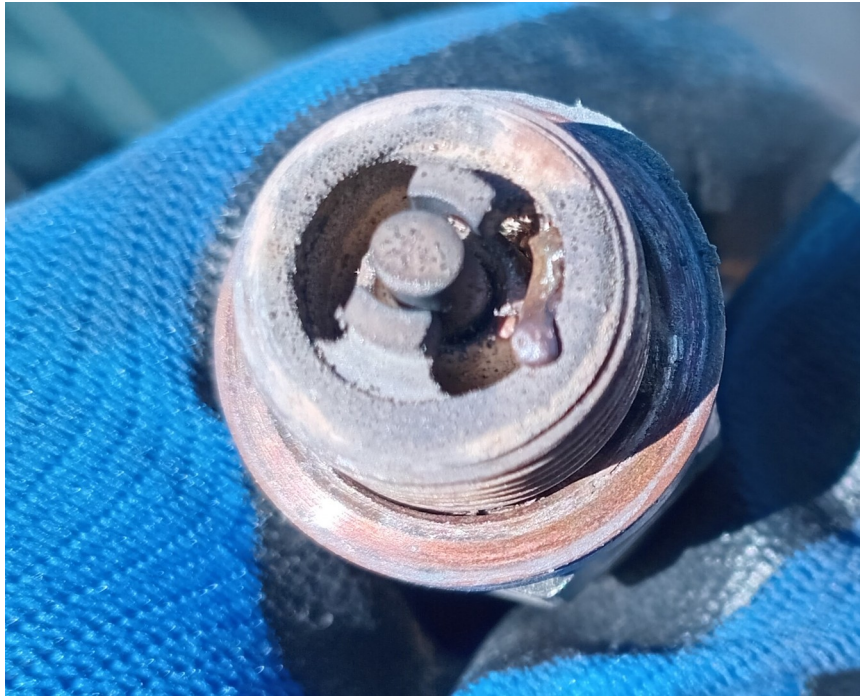
All the lower spark plugs were terribly clogged with lead! The ones on the front two cylinders were the worst, by far. I stuck an inspection camera into the jugs and saw that the front two piston crowns were much more heavily coated with lead chunks and deposits than they've ever been. Even the spark plug holes had chunks of lead around them.

One of the front two lower spark plugs heavily fouled with lead deposits.

What I didn't realize is how the more frequent slow speed, low-RPM, and low temperature flying was affecting the Cav's engine. So, there in the middle of the night I reckoned that the lower revs, slower speeds, cooler temperatures, and higher leaded fuel content, were fouling my spark plugs to the point of drastically affecting engine operation.

So, what's the remedy? I replaced the front two lower spark plugs with new ones. Then I thoroughly cleaned and re-gapped the other two. The rest was simple. I needed to fly the snot out of the Cav for the next several hours, well-leaned, to get things hot enough to rid the cylinder innards of all that excess lead.

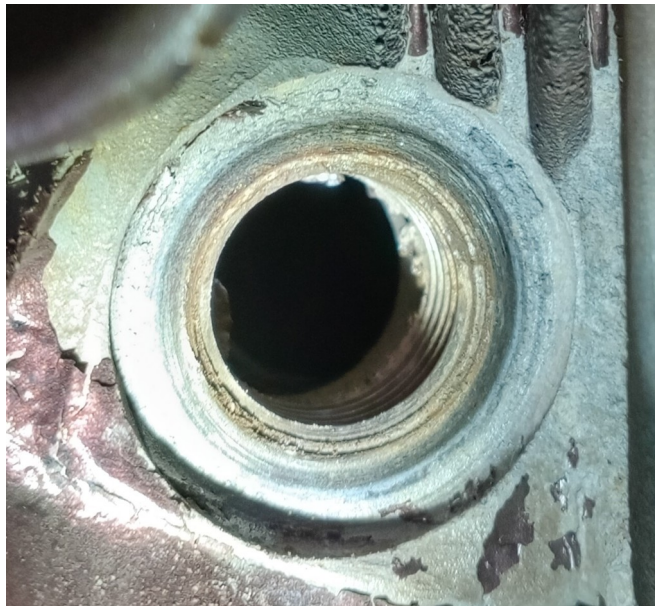
One of the spark plug holes with heavy lead deposits at the end of the threads.

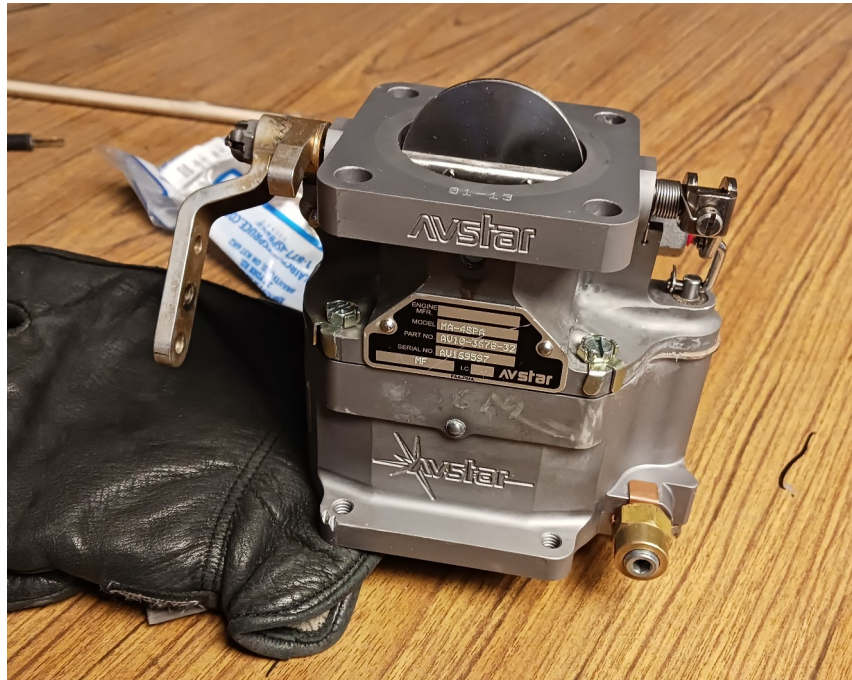
Maybe it was a carburetor issue. I felt that was equally unlikely because I had the carb re-built with updated floats only a year and 75 hours prior.

An innocent and freshly re-built Cav carb, which had only 75 hours on it when the trouble started. Fortunately, not the problem.
