Maintenance Misdiagnosis

by Stu Simpson

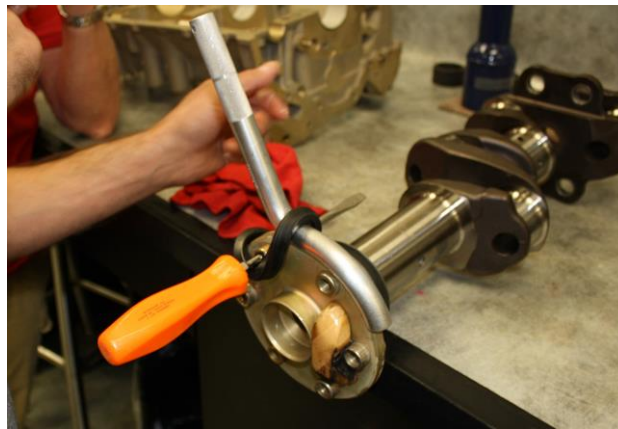
The Lycoming one-piece crank seal and the special tool that stretches it over the prop flange. The curved part of the lever is grooved to slide around the flange. Courtesy www.glasair-owners.com

Lycoming front crank seals come in two types; a solid rubber piece that stretches over the prop flange with enormous difficulty, and a type that is split to fit over the crank behind the flange with minimal fuss. There are pros and cons to each. The split style, which I've always used, goes on much, much more easily, but is said to be not as long lasting. The solid style is apparently more durable in the long term, but can be really tough to install over the prop flange. It requires a special tool that is used ONLY for that one task, and which costs about \$140 dollars.

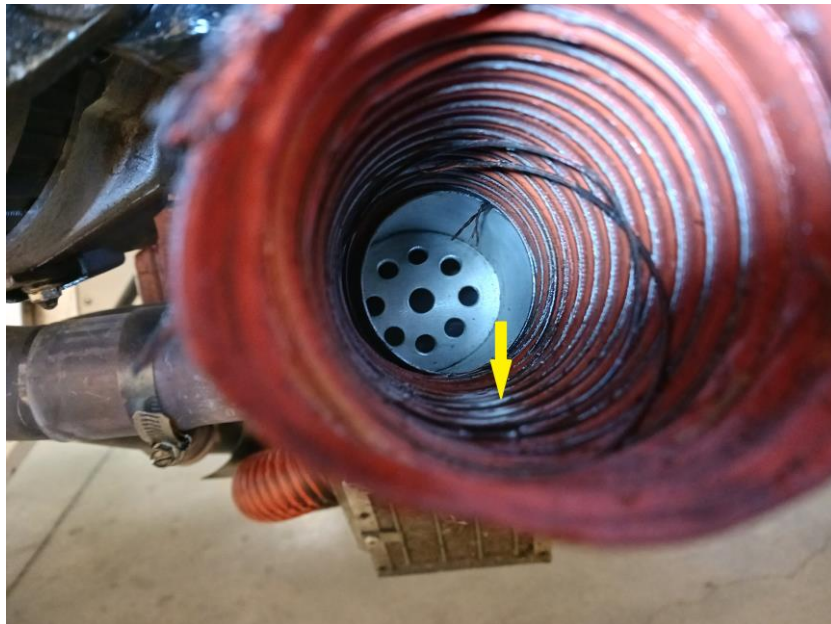
The cabin heat muff intake tube sits beneath the front crank seal. Arrow shows oil in the tube, which then gets into the heat muff and stinks up the cabin.

The factor that biased me toward a crank seal leak was how oil was getting into the cabin heat muff right under the seal. Of course, with the way air squirrels around in the bottom half of the cowling, it's easy to see how that could happen with the leaking return lines, especially with the significant amount of oil that had leaked.

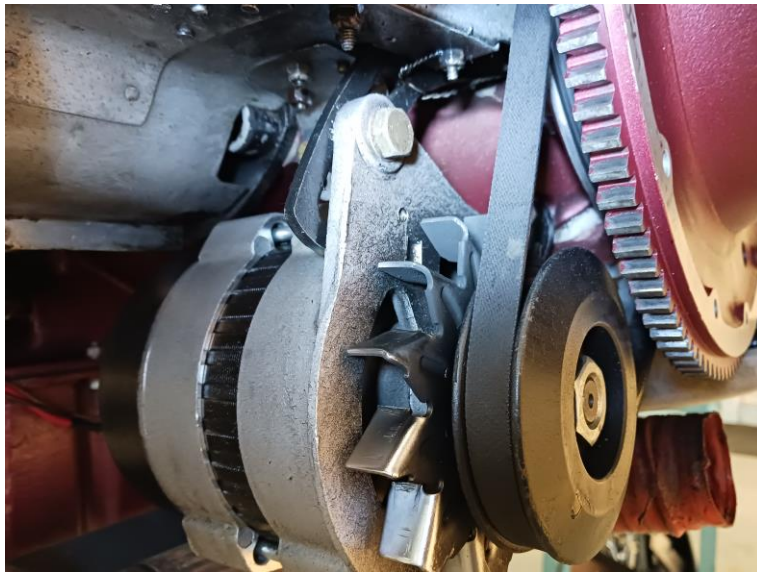
The front of the alternator showing a mixture of oil residue with normally occurring 'dust' from the belt as it wears.

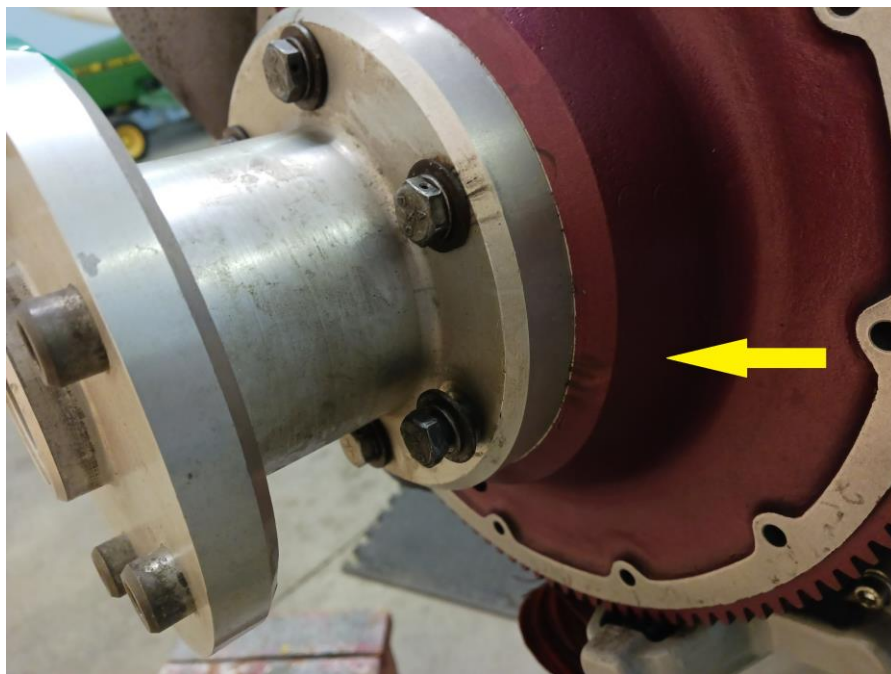
The starter ring assembly and prop extension. There's some oil residue on the extension, but the bowl-shaped inside of the ring assembly, which surrounds the crank seal where the arrow points, was dry.

In fact, the crank seal itself was absolutely dry. The seal was tight and there was no evidence at all of any leakage. Bob and I quickly concluded the crank seal was not the problem.

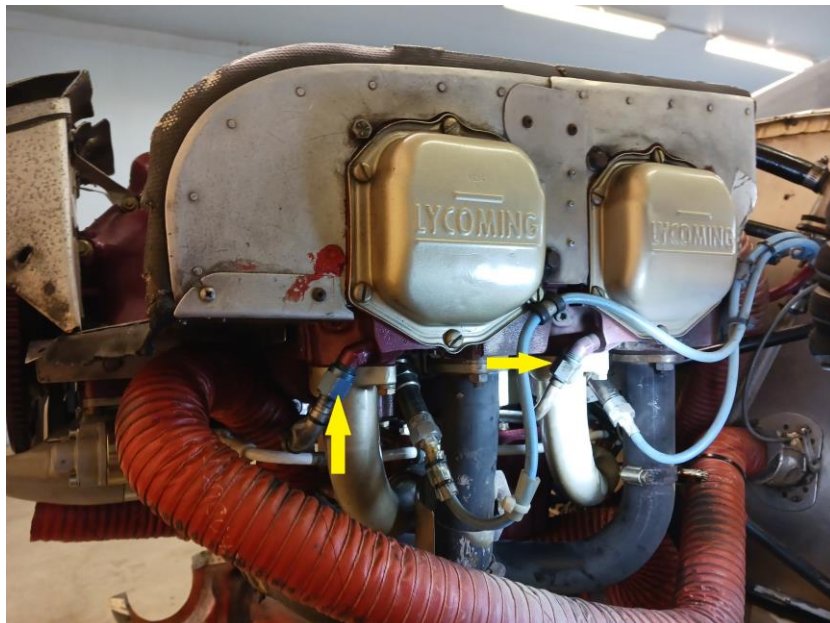
Upon further examination I discovered there was noticeably more oil residue on the left side of the engine than on the right. The oil also seemed to be heaviest atop the flange where the oil sump bolts to the bottom of the engine case. And then I noticed the oil return lines on cylinders #2 and #4, especially #2, were heavily covered in oil.

Arrows point to the cylinder head oil drain lines on cylinders #2 and #4.

The rubber hose on cylinders' #2 and #4 drain lines had deteriorated to the point where at least one of them was leaking, either from the hose clamp joint, or from a crack in the rubber. In any case, I replaced both pieces of hose from stock in my hangar. Then Bob and I commenced re-assembling the front end of the Cav.

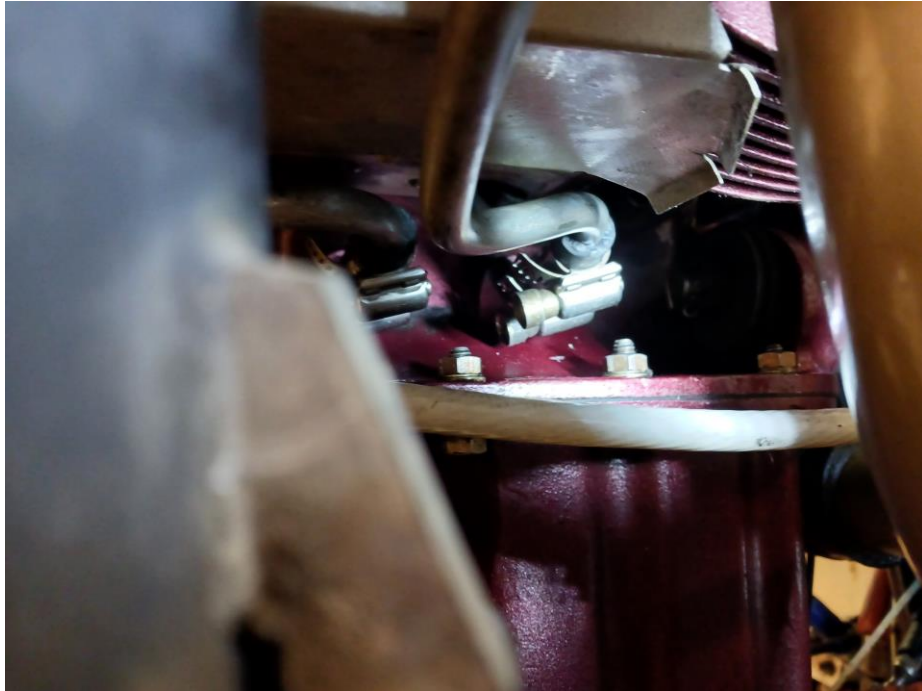
On the Lycoming O-320 each cylinder has a 3/8" metal line that drains excess oil from the cylinder heads back to the crank case and sump. The line joins to the case via a 2.5" length of rubber hose slipped over a barb threaded into the case itself. Hose clamps secure the rubber in place.

A closer look past the exhaust and intake tubes at how the oil drain lines route into rubber connection hoses beneath the cylinders.

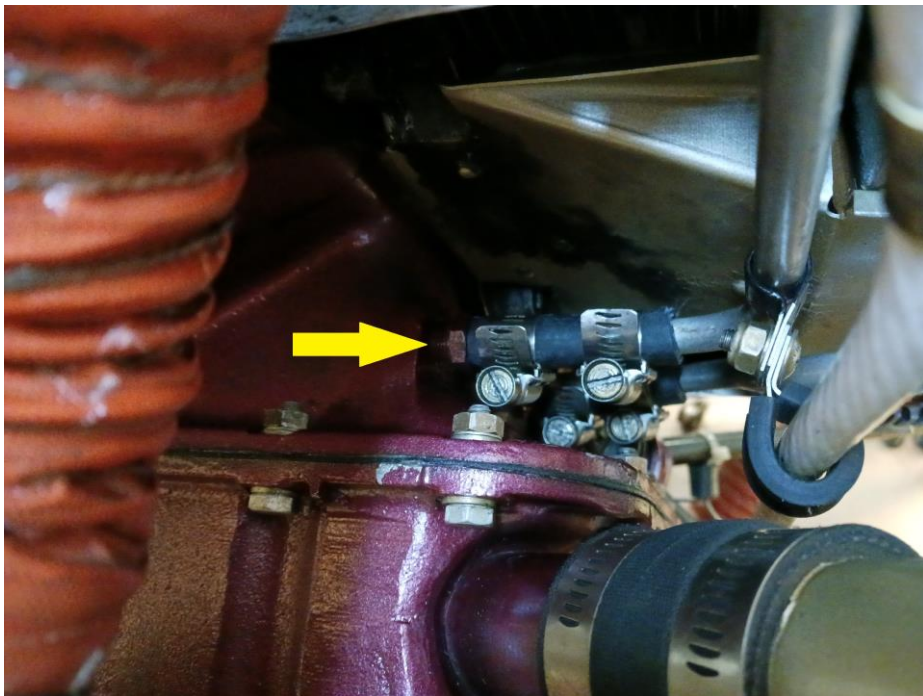
View looking aft at how the oil drain line and the rubber hose sections clamp to the barb fitting (at the arrow) threaded into the case. Photo shows the new hose sections.

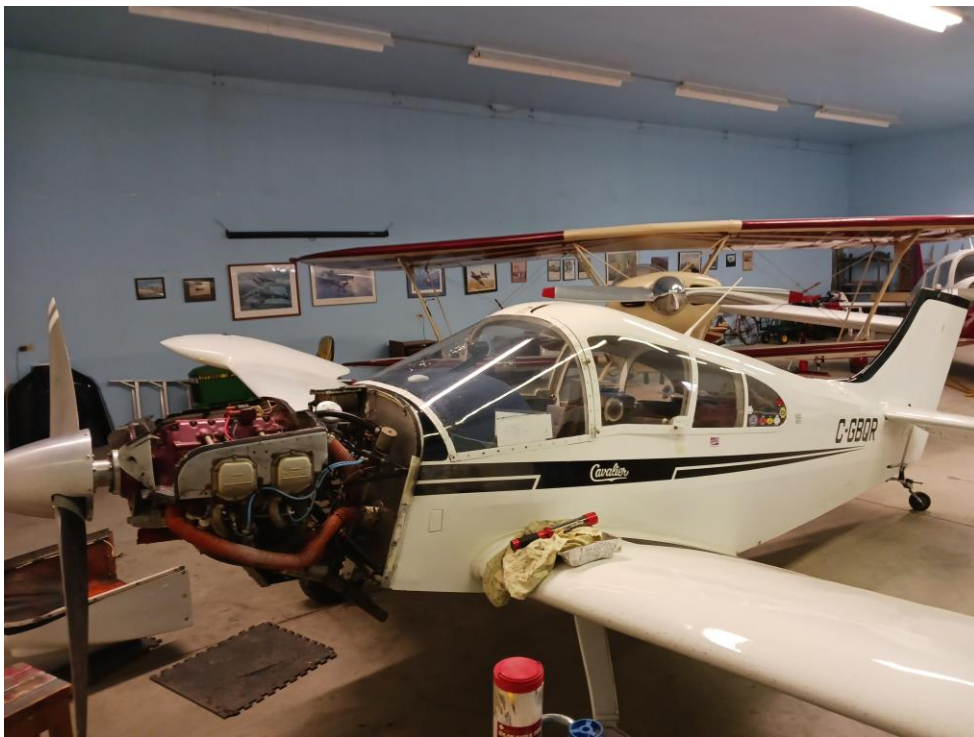
The Cavalier's all ready to get fully dressed again with no more leaks. Kirkby's Starduster and Cherokee 235 are in the background.
